# Manhole Inspection Summary

Manhole # S19I1\_011MH

Insp Date: **3/5/09 11:15 AM**

**Location** Address: **2517**  
**SOUTHDENE-MARBOURNE-ALLEY**

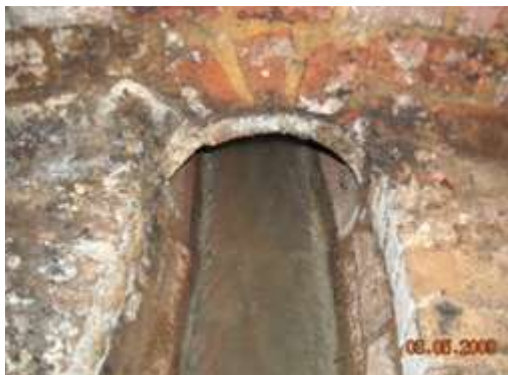
Defect 4

**Bench** ☒ Exists Material: **Brick** ☐ Parged  
Condition: ☐ Sound ☐ Cracked ☐ Root Intrusion ☒ **Deteriorated** ☐ Leaks ☐ Debris

Bench Deteriorating

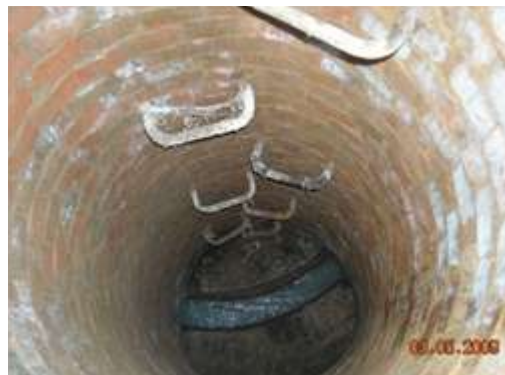
Defect 3

**Steps** Count: **7** Missing: **0** ☒ **Corroded**

CORRODED STEPS

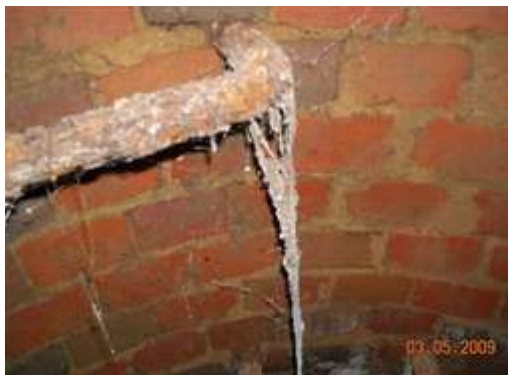
Defect 2

**Surcharge** ☒ **Evidence Of Surcharge** Depth: **0** (ft.) ☐ Active Surcharge Present

EVIDENCE OF SURCHARGE

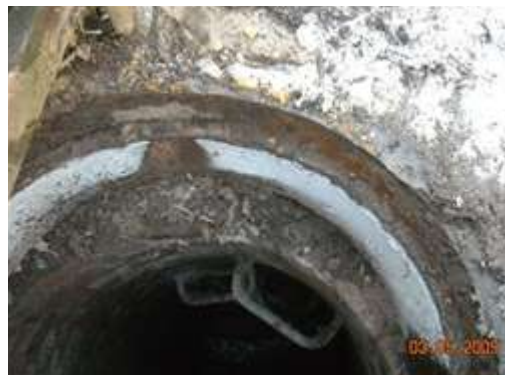
Defect 1

**Frame** Offset: **3** (in.) Condition: ☒ Sound ☐ Cracked ☐ Leaks

FRAME OFFSET

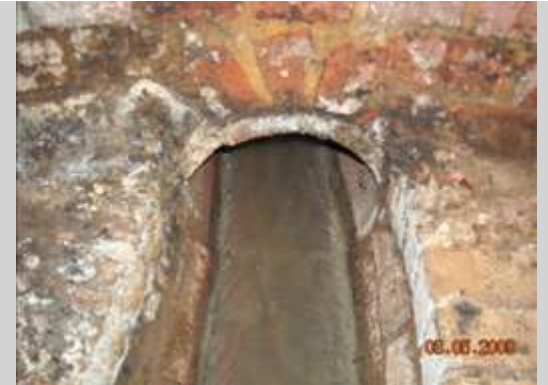
12 O'Clock Outflow

10 in. Circular Gravity Sewer  
Pipe Out @ 12 O'Clock

Pipe Height: **10.8** (in.) Rod and Bar (Angled)  
Pipe Material: **Clay** ☐ Pipe Lined  
Invert Depth: **13.10** (ft.) Flow Characteristics: **Fast**  
Deposits: ☒ None ☐ Mud ☐ Sludge ☐ Debris ☐ Grease  
Silt Depth: **0** (in.) Deposits Extent:  
Infiltration: **None** Pipe Seal Cond: **Sound**

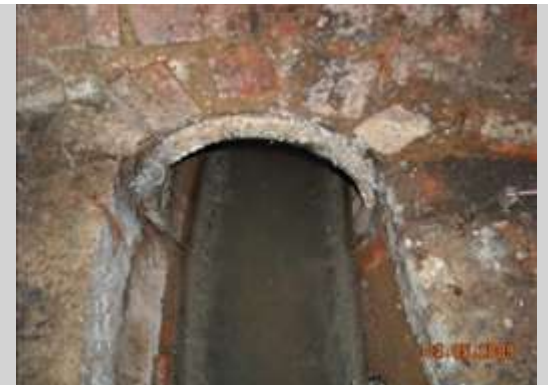
7 O'Clock Inflow

10 in. Circular Gravity Sewer  
Pipe In @ 7 O'Clock

Pipe Height: **10.8** (in.) Rod and Bar (Angled)  
Pipe Material: **Clay** ☐ Pipe Lined  
Invert Depth: **13.00** (ft.) Flow Characteristics: **Fast**  
Deposits: ☒ None ☐ Mud ☐ Sludge ☐ Debris ☐ Grease  
Silt Depth: **0** (in.) Deposits Extent:  
Infiltration: **None** Pipe Seal Cond: **Sound**
